**“BROOKFIELD DAM OPERATIONS STRAND, INJURE
ENDANGERED ATLANTIC SALMON”**

Field Summary of Atlantic Salmon Stranding Rescue at Lockwood Dam

Lockwood Dam Flashboard Replacement Salmon Rescue (ME DMR)

June 15, 2021

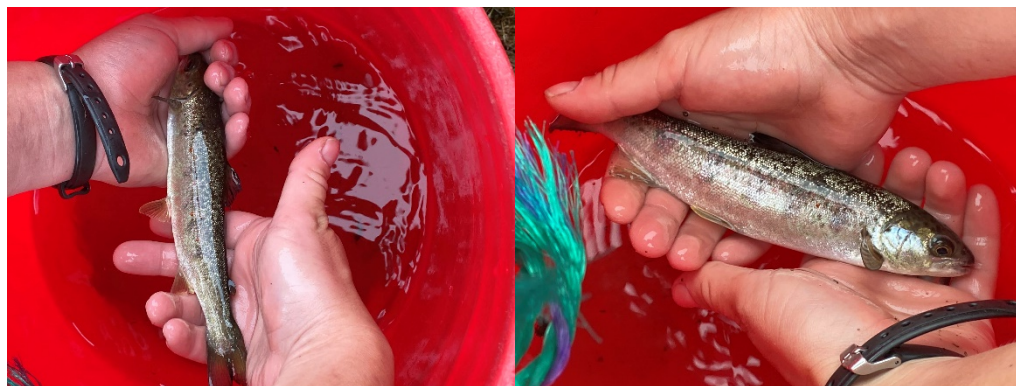
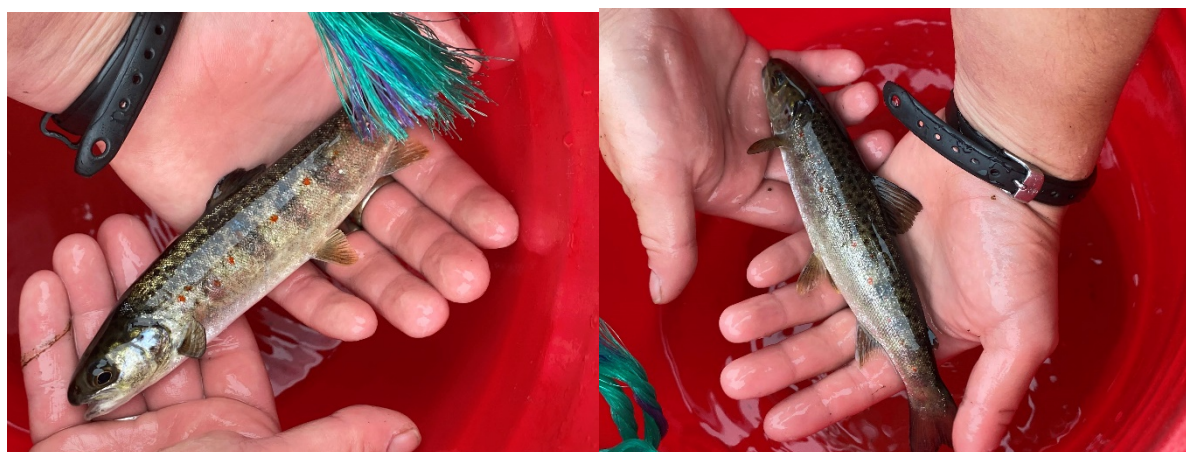
A DMR staff found approximately 10 smolts in one pool in the same area that the adult salmon was found. Staff then found 3 more smolts in another pool. Then approximately 10 in the large pool under the Rt. 100 bridge. Here are some pictures. They are most likely Atlantic salmon as they were very silvery and all a similar size.

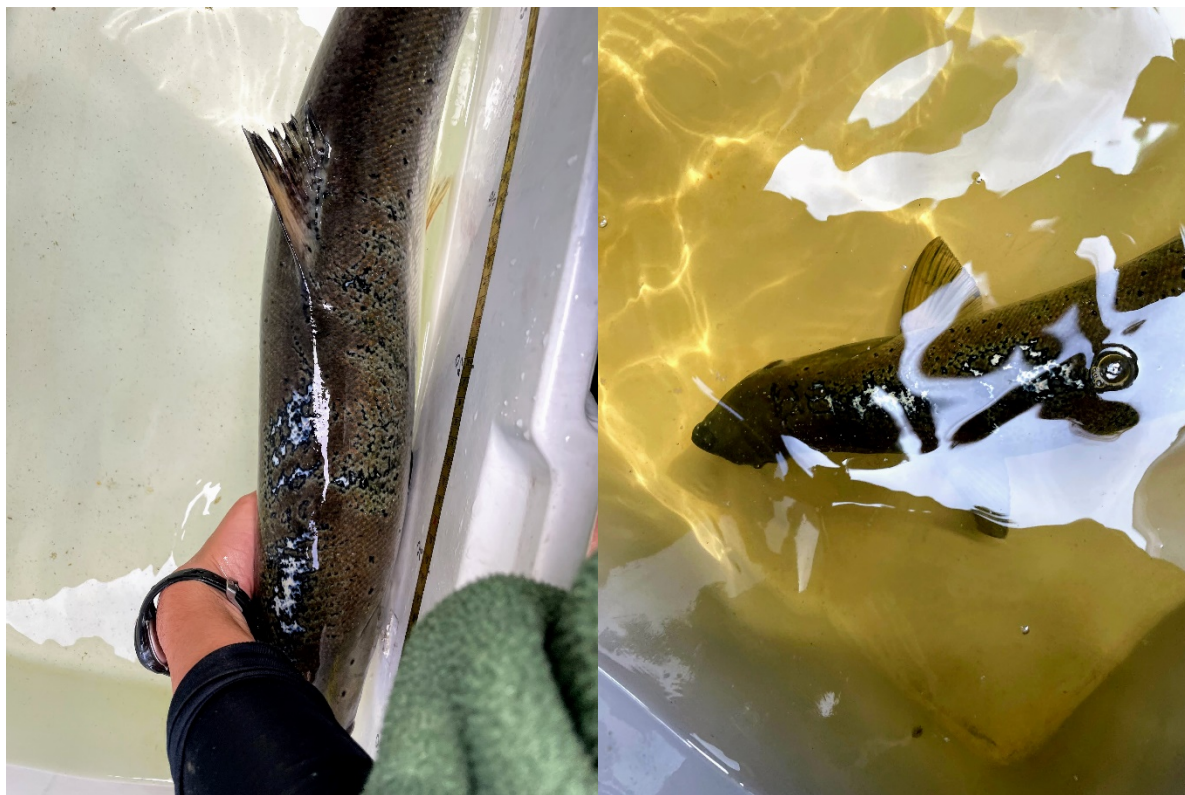
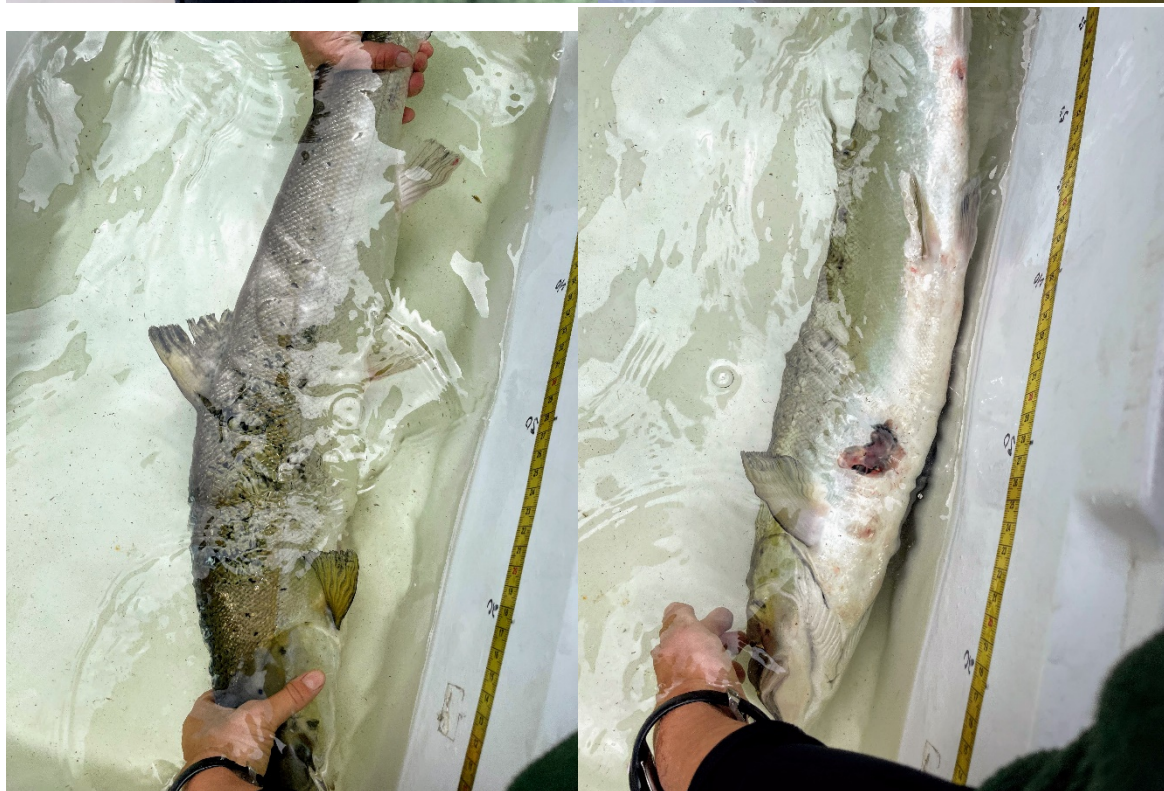
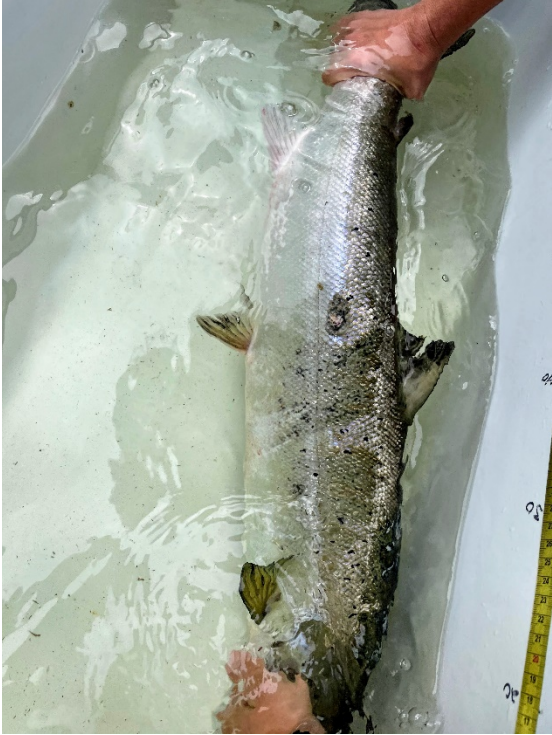
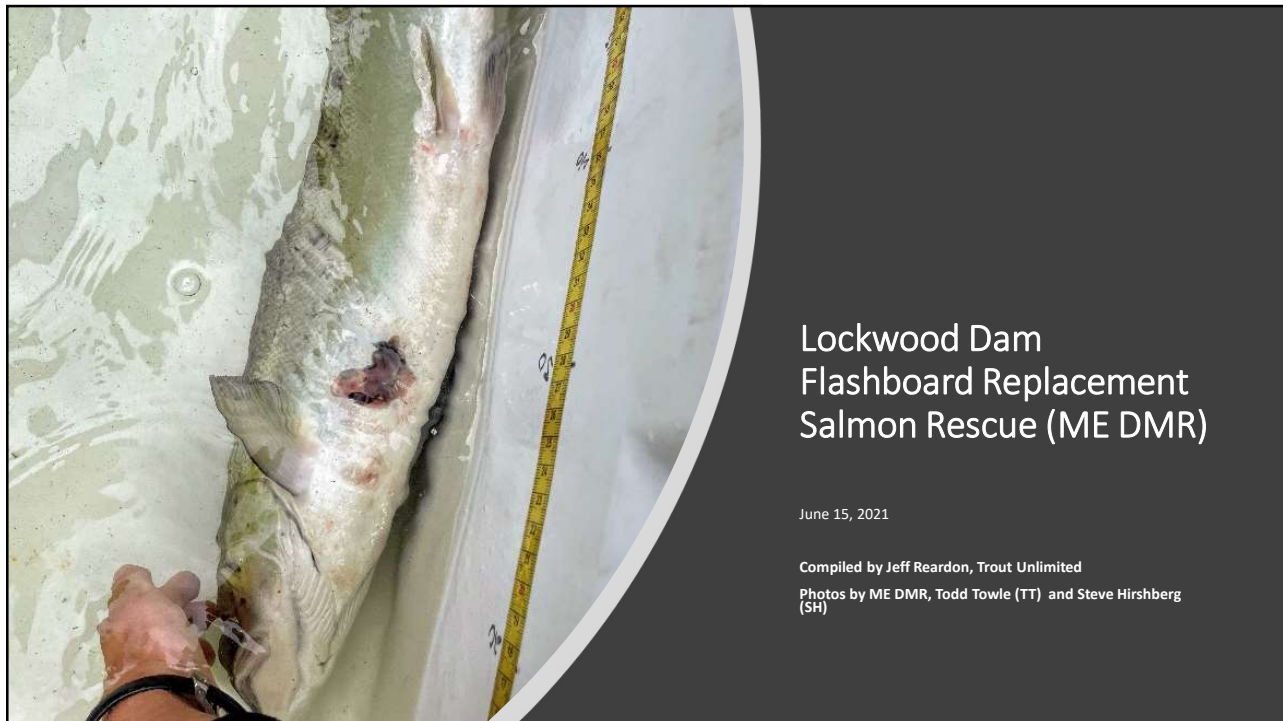
The one Atlantic salmon that was rescued from the ledges was brought upstream and released in the Sandy River at 4pm. It was a male that had a fork length of 73cm. The fish appeared to still be silver. It was noted to have brackish water lice, scraped up body dorsally, scraped up sides (both left and right), an abrasion ventrally, a bruise on its left side, a lamprey wound scar on its right side, a split dorsal fin, a split caudal fin and a bruised snout. See below. After reading the scales from this fish, it was a naturally reared 2 freshwater, 2 sea winter Atlantic salmon.

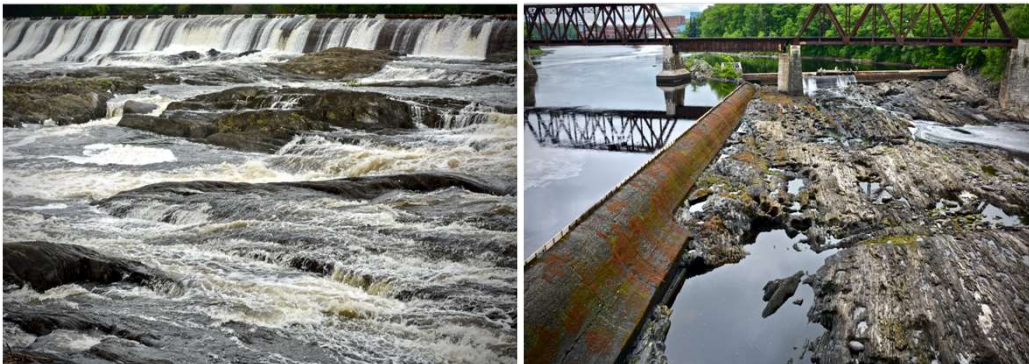
1

Annual flashboard replacement dewateres ledges below Lockwood Dam. Salmon and other fish became trapped in isolated pools. (TT)

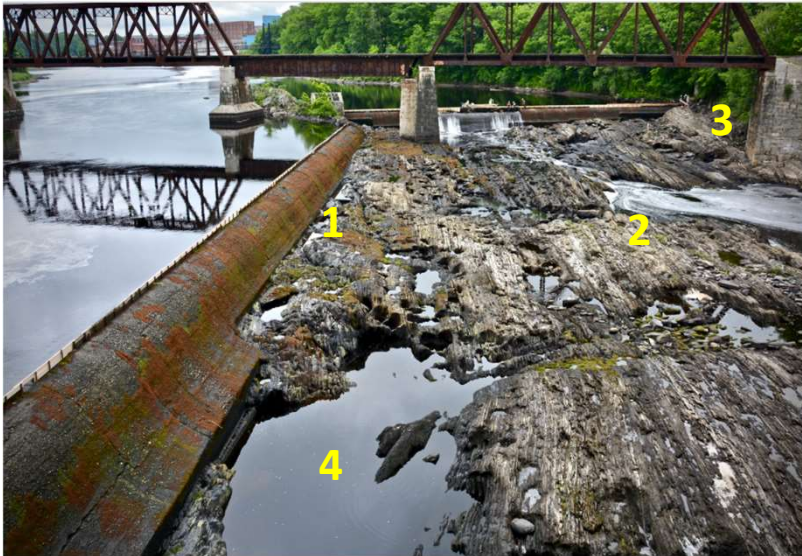
Salmon Rescue Locations (TT)

1. Appx. location of single rescued salmon.
2. Canoe transfer location.
3. Human chain over ledges to transport truck.
4. Isolated pool with at least 2 additional stranded salmon that could not be captured. One had obvious injuries and scars.

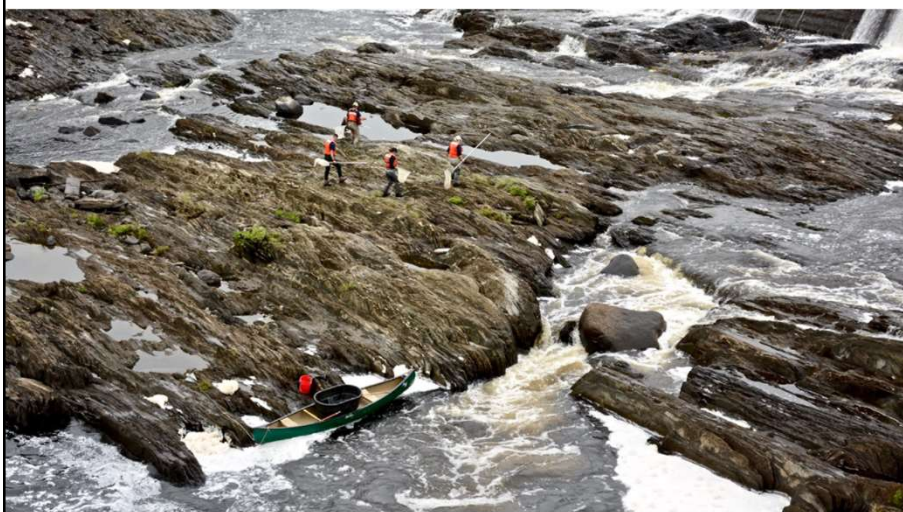
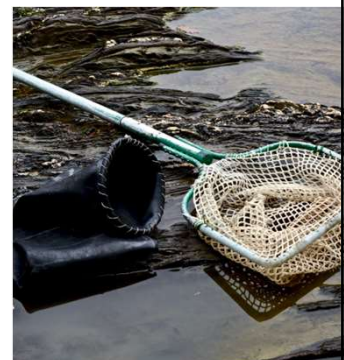
3

DMR crew deployed to search as ledges dewater. (TT)

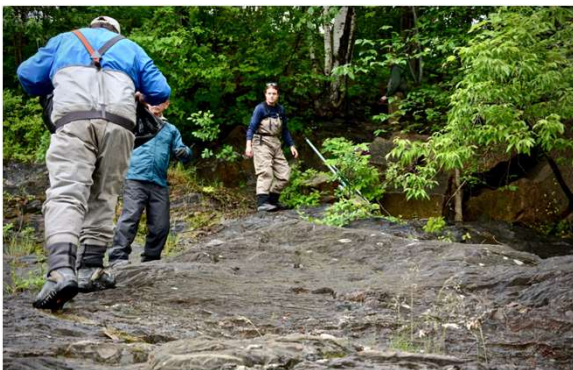
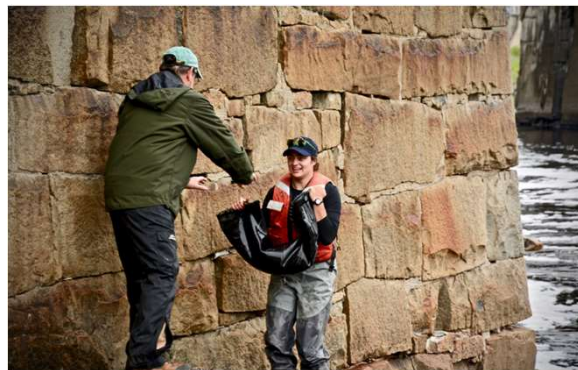
9

Bucket Brigade to Path. (TT)

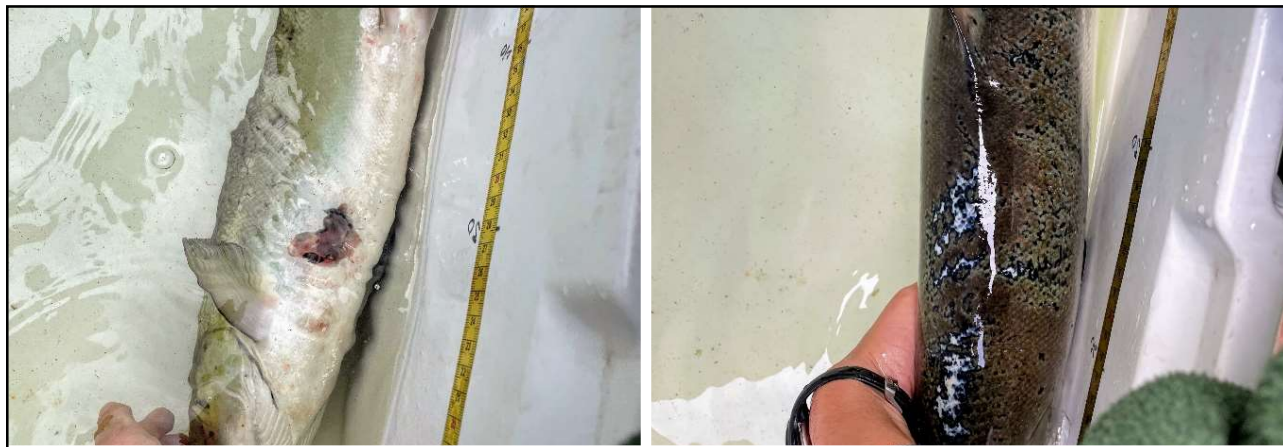
13

Injuries to captured salmon. "scraped up body dorsally, scraped up sides (both left and right), an abrasion ventrally, a bruise on it's left side, a lamprey wound scar on its right side, a split dorsal fin, a split caudal fin and a bruised snout." (DMR text and photos)

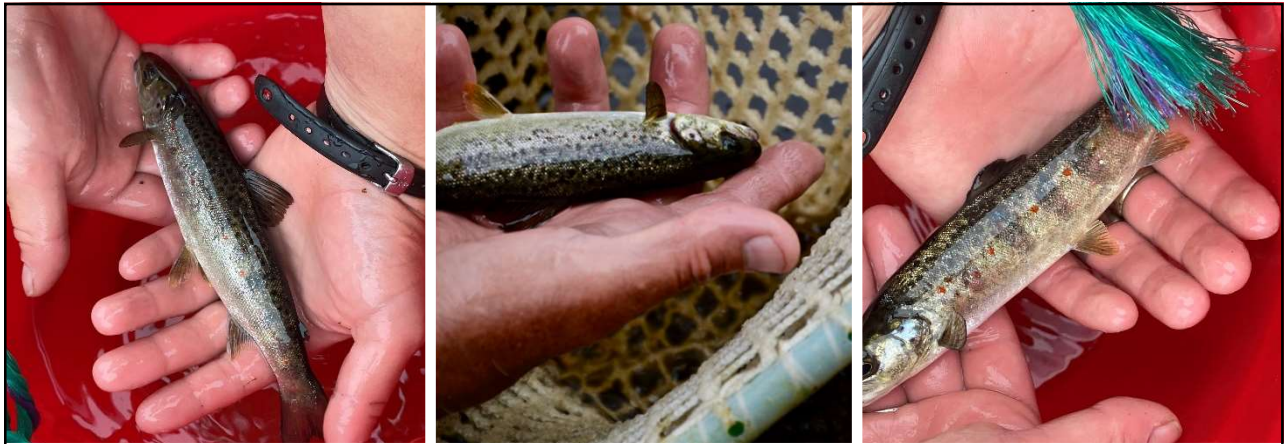
14

Nearly 2 dozen salmon smolts were also captured and relocated. (ME DMR and TT)
