# Escalante River Aquatic Assessment Final Report

Prepared for the Escalante River  
Watershed Partnership and the  
Bureau of Land Management

By Trout Unlimited

April 2015

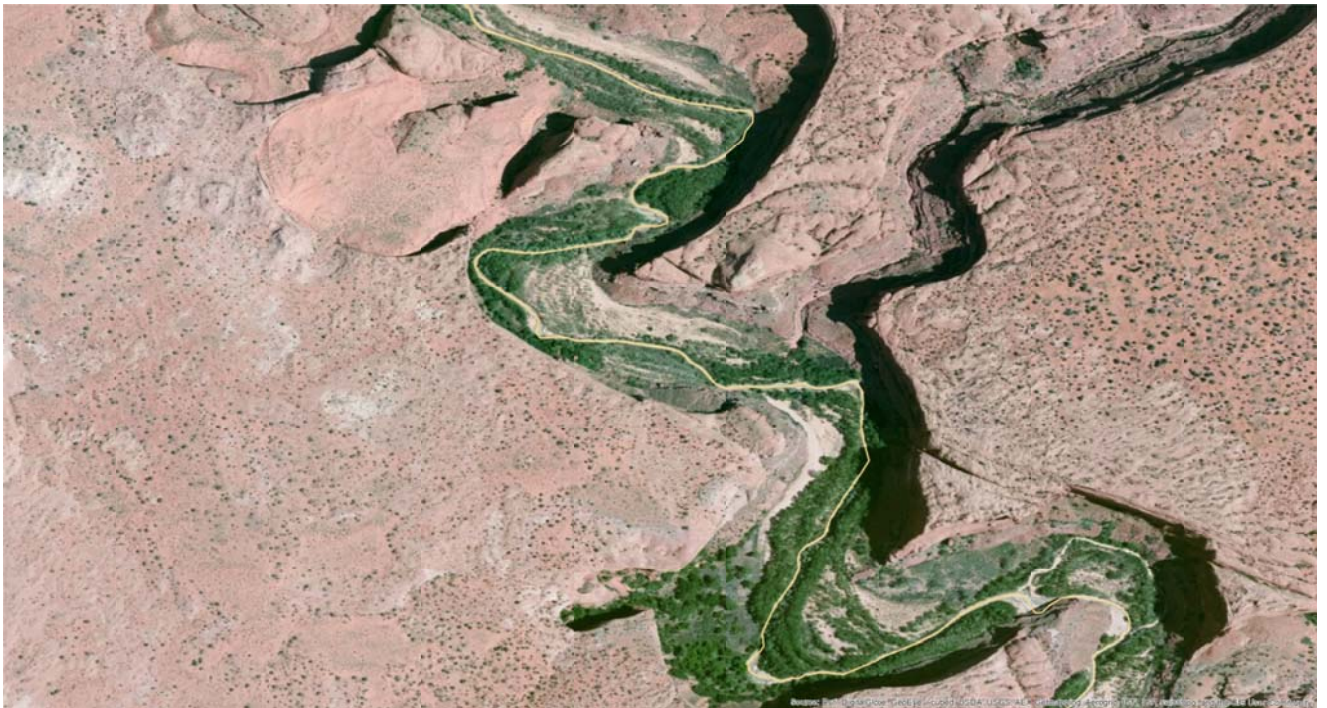
**Figure B-2.** Reduced braiding and increased upland and woody riparian vegetation from 1951 to 2011 is evident in this stream reach between The Gulch and Harris Wash.

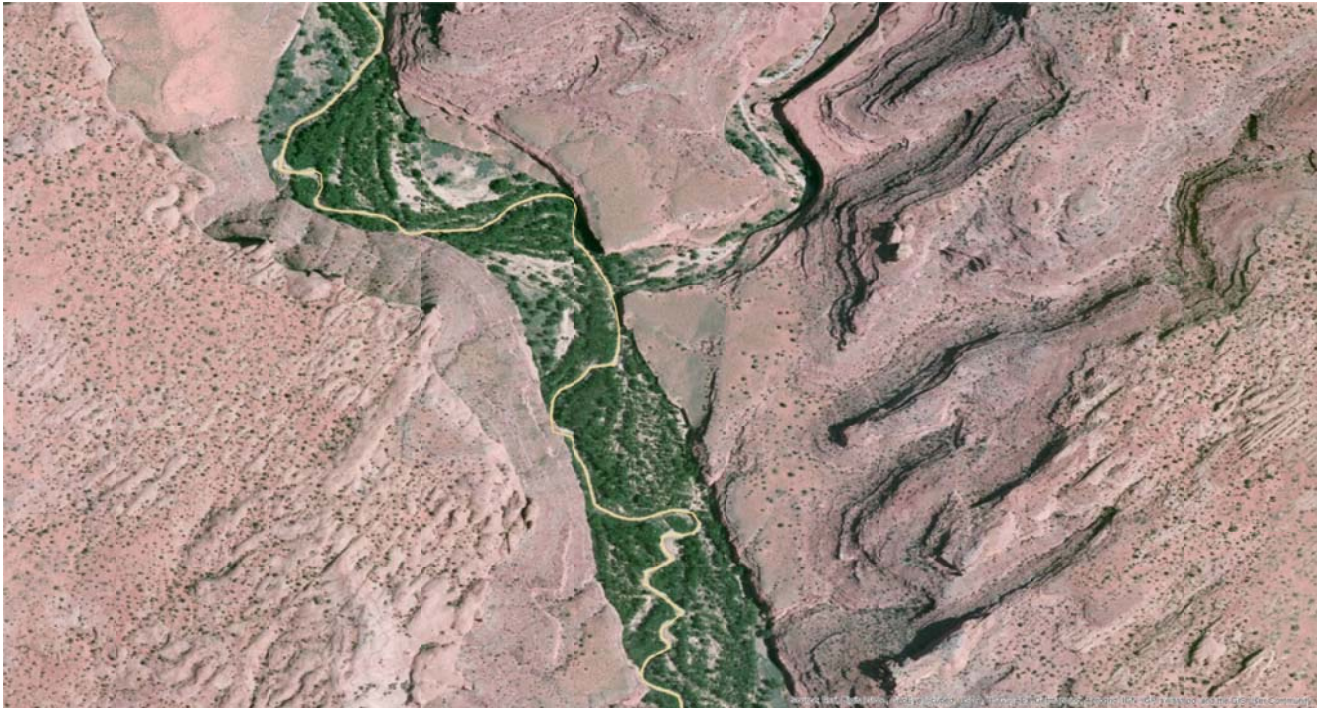
**Figure B-3.** Reduced braiding, change in channel alignment and increased upland and woody riparian vegetation is evident between 1951 and 2011 in this stream reach below Harris Wash.

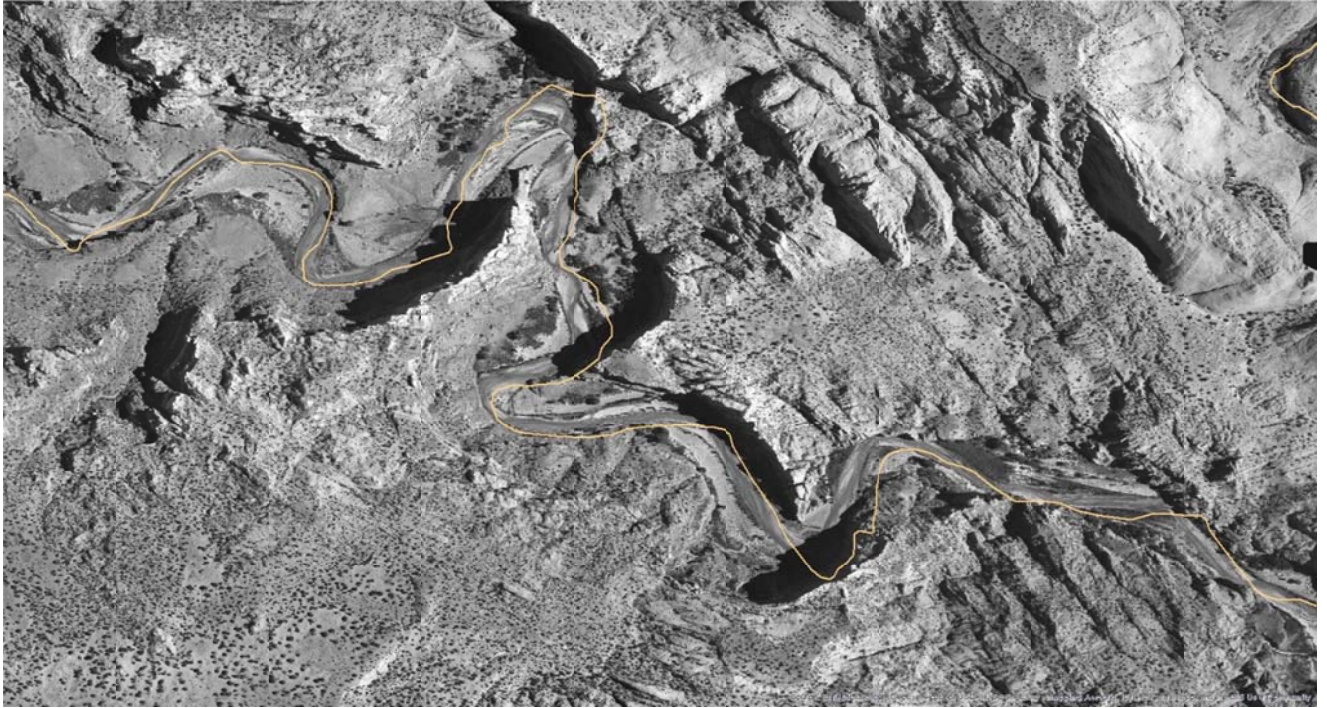
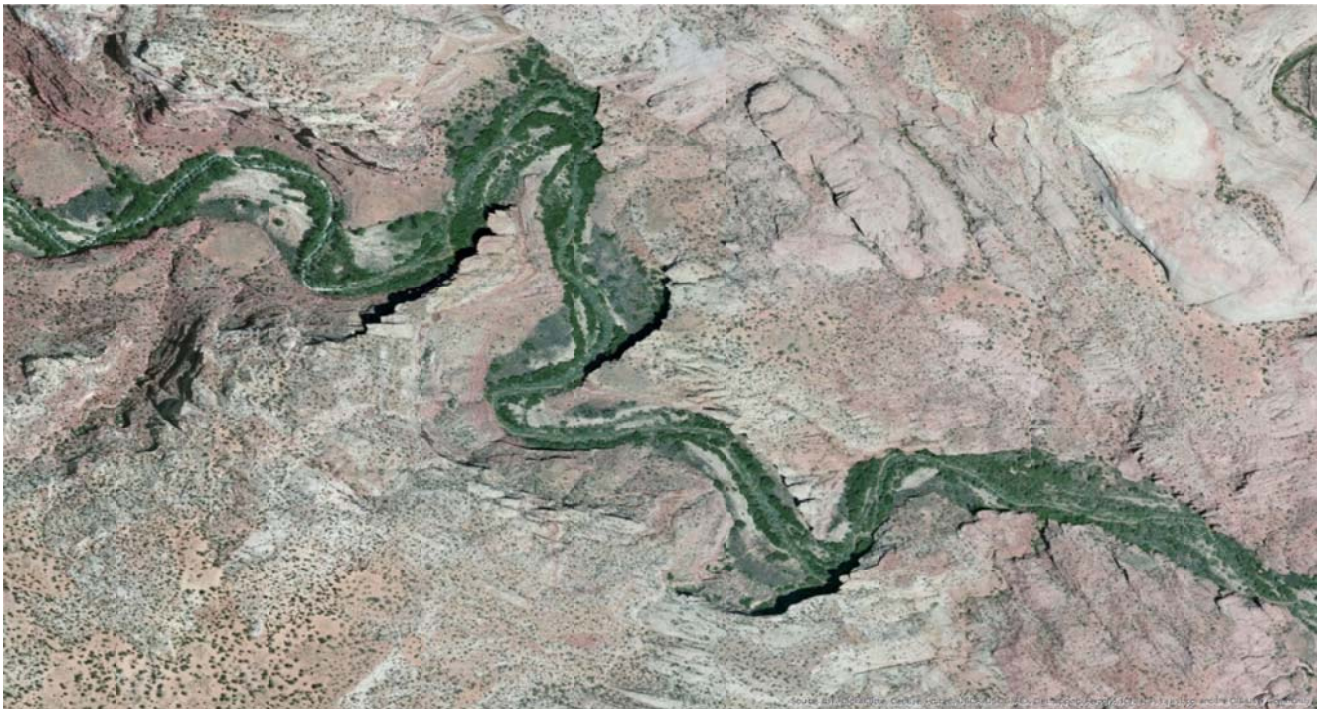
**Figure B-4.** Some changes in channel alignment are evident between 1960 and 2011 as well as an increase in upland and woody riparian vegetation and Russian Olive (light green) in this stream reach between Calf Creek and Deer Creek.
