## RESTORING TROUT HABITAT IN DIFFICULT TO ACCESS AREAS USING MOBILE WOOD ADDITIONS

James M. MacCartney<sup>1</sup>, John A. Magee<sup>2</sup>, and John J. Field<sup>3</sup>,

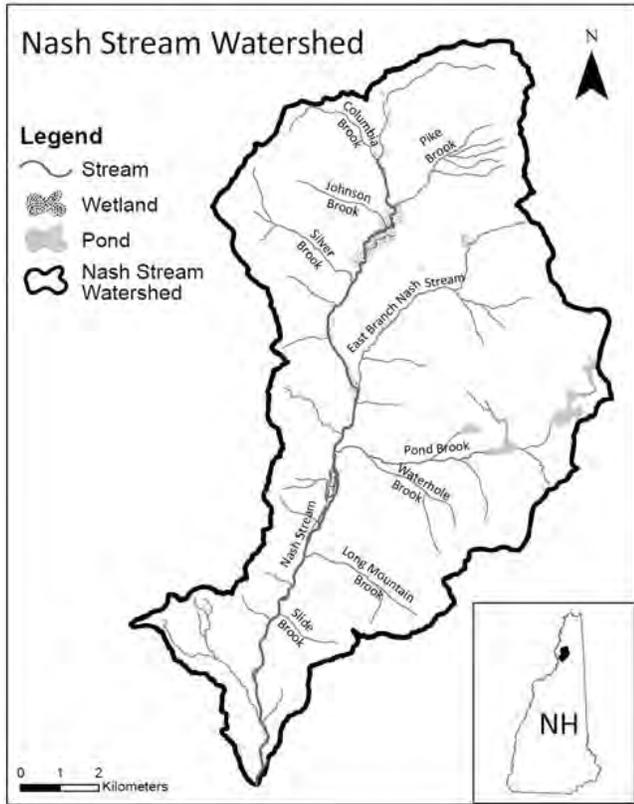
Figure 1. Nash Stream Watershed study area.

Nash Stream is a fourth order river, with a watershed area of 115 km<sup>2</sup>, located in northern New Hampshire (Figure 1) and drains into the Upper Ammonoosuc River before reaching the Connecticut

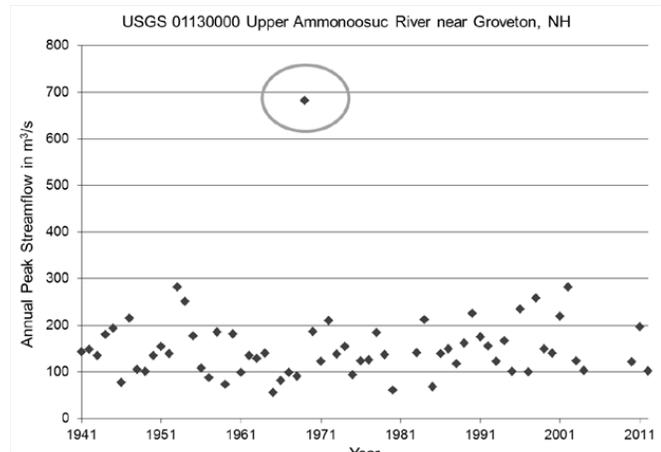
Figure 2. Annual peak streamflow at the USGS Upper Ammonoosuc River gage. The maximum discharge of 682 m<sup>3</sup>/s (circled) resulted from a dam break on Nash Stream.

The dam failure produced the highest flow ever recorded at the U.S. Geological Service gage on the Upper Ammonoosuc River (USGS 2013a) located 300 m downstream of the Nash Stream confluence (Figure 2). The estimated peak discharge at the USGS gage from the dam break was 682 m<sup>3</sup>/s, a value that is more than two times greater than any other reported peak at this gage and approximately four times greater than the estimated 500-yr recurrence interval peak flow (167 m<sup>3</sup>/s) for Nash Stream (USGS 2013b).

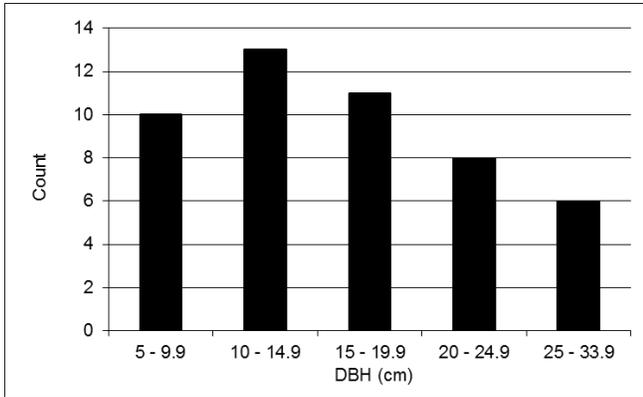
Figure 3. Size range of mobile wood additions to Nash Stream, 2010 and 2011.

The trees ranged in size from 5 to 34 cm DBH (Figure 3); most fit the definition of large wood by Schuett-Hames et al. (1999). Small diameter trees were intentionally selected for insertion because the primary objective was to ensure their transport to downstream target reaches and avoid overloading the channel with large trees that might impede transport or encourage beaver activity that would preclude or limit the transport of the tagged trees during the study.

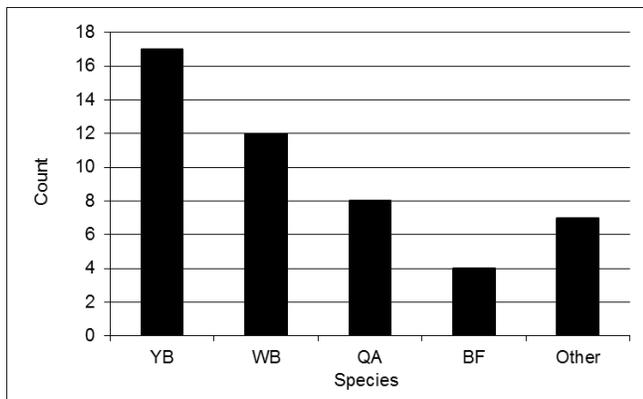
Figure 4. Tree species added to Nash Stream included Yellow birch *Betula alleghaniensis* (YB), White birch *Betula papyrifera* (WB), Quaking aspen *Populus tremuloides* (QA), Balsam fir *Abies balsamea* (BF), and five other species (Other.)

A total of nine tree species were used. The four primary species in descending order of prevalence were: Yellow birch *Betula alleghaniensis* (YB), White birch *Betula papyrifera* (WB), Quaking aspen *Populus tremuloides* (QA), and Balsam fir *Abies balsamea* (BF). Five additional species (Other) were also used: Red maple *Acer rubrum*, Sugar maple *Acer saccharum*, Red spruce *Picea rubens*, Black cherry *Prunus serotina* and Black willow *Salix nigra* (Figure 4).

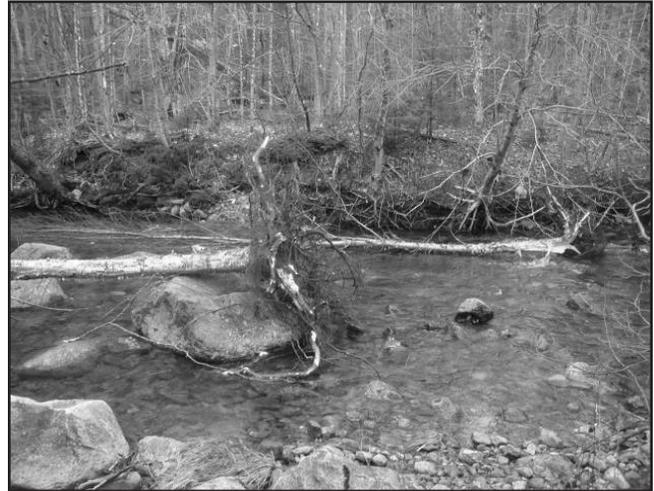
Figure 5. Photo showing MWA were placed at various elevations in Nash Stream to promote transport at different stages during high flow events. Photo by authors.

The trees were deployed at various elevations relative to bank-full to promote release and downstream transport at different flow stages (Figure 5). Twenty-seven trees were placed in the water, 12 were placed on bars at the channel margin, and nine were inserted at bank-full elevation in the active channel.

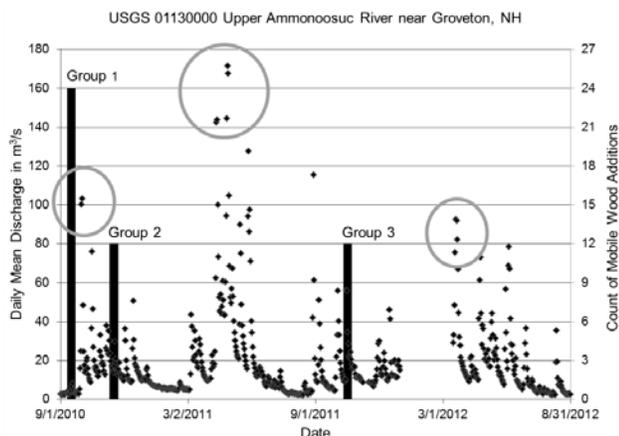
Figure 6. Daily mean discharges for the Upper Ammonoosuc gage. Flows that transported each group of mobile wood are circled.

During the study period, the Upper Ammonoosuc River gauge recorded five near bank-full flow events of greater than 90 m<sup>3</sup>/s (USGS 2013a). The maximum discharge was 171 m<sup>3</sup>/s. All groups moved at or near the PK2 discharge as measured at the USGS Upper Ammonoosuc River gage (140 m<sup>3</sup>/s; Figure 6). Estimated PK2 streamflow in the vicinity of where the wood was installed is approximately 23 m<sup>3</sup>/s (USGS 2013b).

Three weeks after Group 1 trees were placed into Nash Stream, a 103 m<sup>3</sup>/s discharge from a very large rainfall event on October 2, 2010, transported most of the trees. Group 2 moved in mid-April 2011 at a discharge of about 171 m<sup>3</sup>/s. Group 3 moved in March 2012 at 93 m<sup>3</sup>/s. Much of the wood from Group 1 clustered in just a few locations (Figure 7). Similar transport and accumulation patterns were observed for Groups 2 and 3; large discharge events transported MWA downstream where it tended to accumulate in clusters at valley constrictions or expansions and changes in channel slope or planform, such as at meander bends downstream of straightened channel segments.

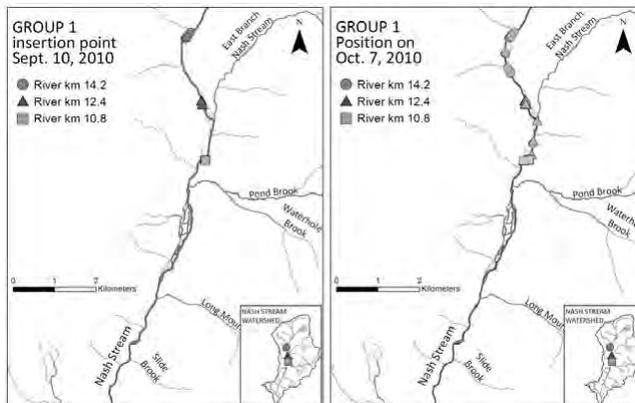
Figure 7. Locations of tagged trees in Nash Stream prior to and after a 103-m<sup>3</sup>/s discharge.

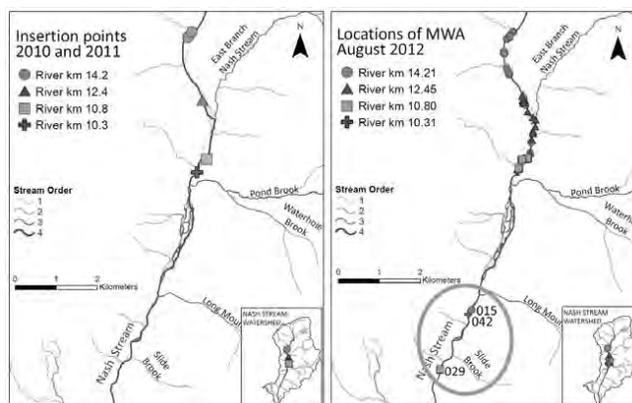
Figure 8. Locations of all three groups of mobile wood in Nash Stream prior to and after transport by high flows. Three trees (circled) moved considerable distances.

Monitoring at the end of the study period in August 2012 showed that 92% of the MWA had dispersed from their original insertion points. Some were transported considerable distances; one 7.6-cm White birch moved 7.8 km (Figure 8). Only 6% of the trees moved more than once; none moved more than twice.

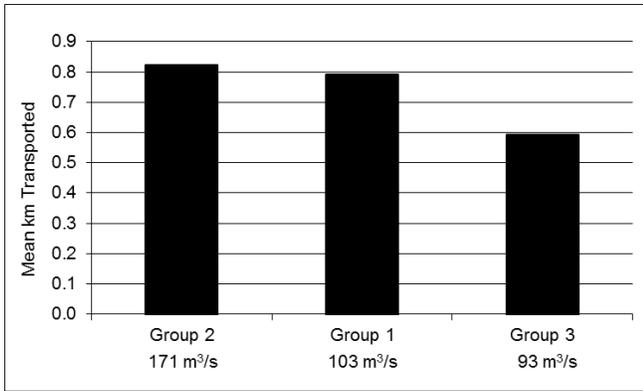
Figure 9. Mean distance that MWA were transported in Nash Stream and daily mean discharge as measured at the Upper Ammonoosuc USGS gage.

There were several apparent trends in the average distance transported and other factors. The MWA tended to travel farther during higher discharges (Figure 9); however, there was a lot of variability in the distances transported within each Group. The range of transport values was 0.00-2.95 km, 0.02-3.23 km, and 0.00-4.07 km for Groups 1, 2 and 3, respectively. Smaller diameter trees tended to move farther than larger trees (Figure 10).

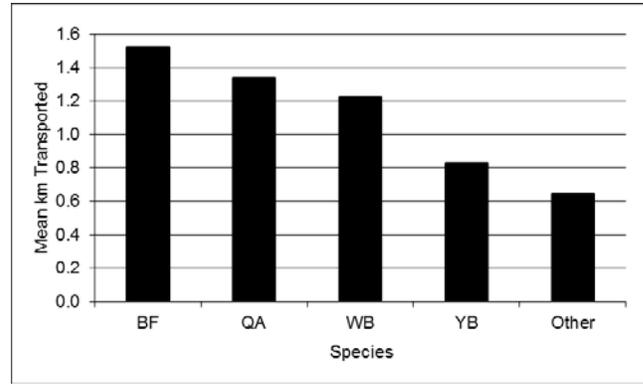
Figure 11. Mean distance trees were transported in Nash Stream and tree species.

We noted that wood density (as reported in Kretschmann 2010) appeared to influence mean transport distance of the trees. Of the four differentiated species, mean transport distance decreased as tree density increased (Figure 11).

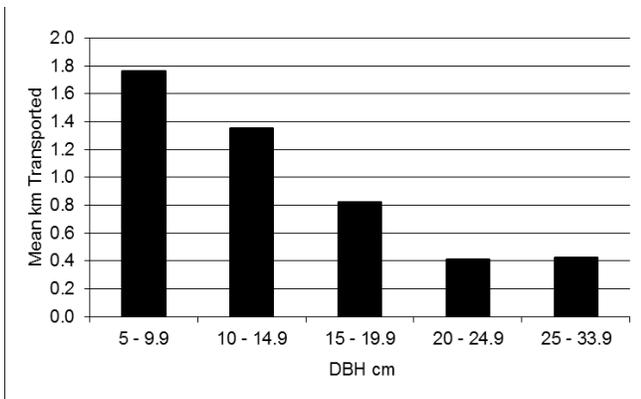
Figure 10. Mean distance trees were transported in Nash Stream and diameter at breast height of the trees.

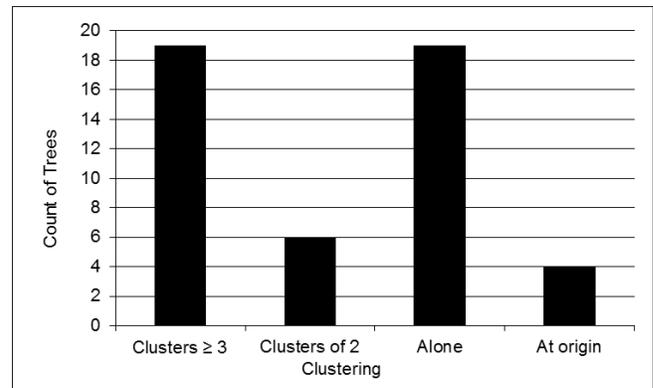
Figure 12. Post-transport clustering of MWA in Nash Stream by end of study period.

By the end of the study period, about half of the trees were deposited with the roots oriented upstream. Nearly half of the trees deposited at bank-full elevation; the rest deposited in the active channel below the bank-full elevation. Slightly more than half

of the trees deposited in clusters of two or more while four trees did not move during this study (Figure 12).

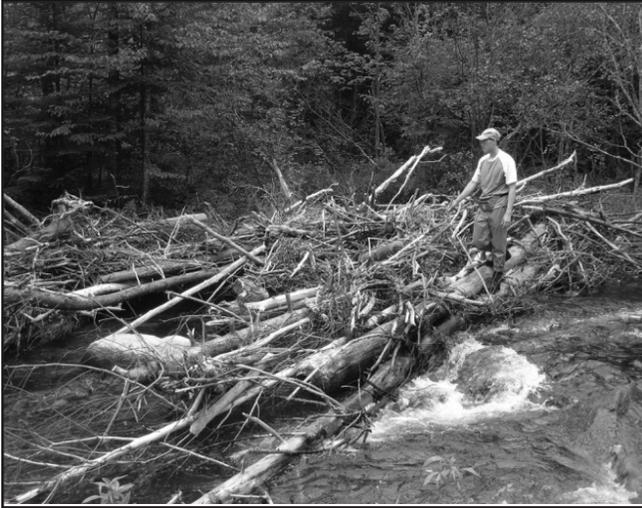
**Figure 13. Photo of a meander jam in Nash Stream created by accumulated MWA and additional naturally recruited material. Photo by authors.**

Most of the MWA that accumulated in clusters were found in jams at the apex of a bar or on a meander bend. One jam contained eight tagged trees along with additional naturally recruited material and formed at a location where no wood accumulations were present prior to the deployment of MWA (Figure 13). The jam appears to be stable; several key members are buried parallel to flow in former high flow chutes, and new vegetation is established on some of the earliest material recruited. The LWM comprising the jam is providing cover for a newly-formed adjacent lateral pool. In addition, a large gravel bar forming upstream has narrowed the low flow channel, flow complexity has increased in the general vicinity of the wood jam, and the substrate particle sizes are better sorted.
