Preface: A Look Back at Driftless Area Science to Plan for Resiliency in an Uncertain Future

Daniel C. Dauwalter^{a,1,2}, Jeff Hastings^{b,1,2}, Marty Melchior^{c,1}, and J. "Duke" Welter^{d,1}

^aTrout Unlimited, Arlington, Virginia, USA; ^bTrout Unlimited, Westby, Wisconsin, USA; ^cInter-Fluve, Inc., Madison, Wisconsin, USA; ^dTrout Unlimited, Viroqua, Wisconsin, USA

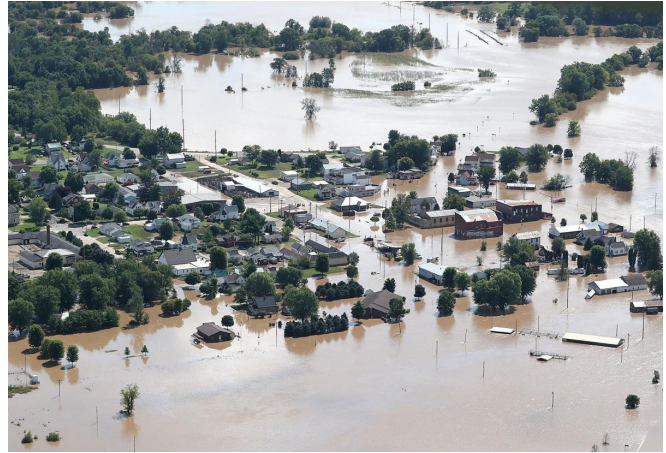
Fig. 1. Flooding in near Viola, Wisconsin in August, 2018. Over 20 inches of rain fell in some areas. Credit: E. Daily, La Crosse Tribune.

Driftless Area (Figs. 1,2). The heaviest impacts of the two rainstorms generally followed Highway 33 from north of Coon Valley to Cashton, Hillsboro and Reedsburg in Wisconsin. But they were not a narrow band. While Ontario received 15.6 inches of rain between August 26 and September 3, Westby got over 18 inches, Elroy over 23 inches and Readstown 11.6 inches, according to the National Weather Service. Just before these events occurred, another event dumped 15.3 inches of rain on Cross Plains and Black Earth Creek in 24 hours, a state record.

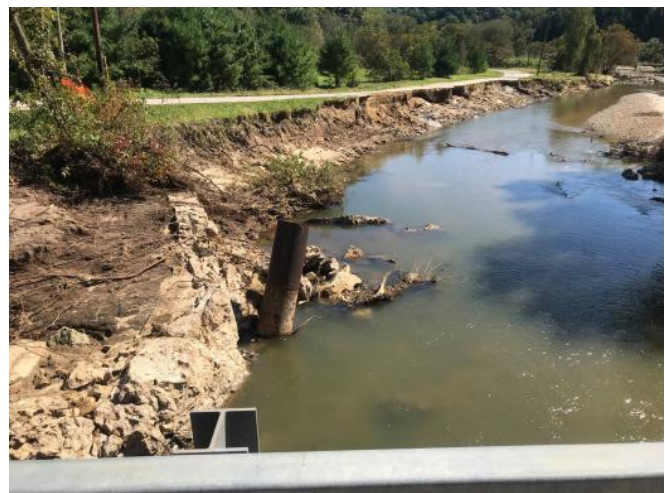
Fig. 3. The view of West Fork downstream from Highway S bridge at Bloomingdale Road, September, 2018. Credit. D. Welter.

That rain resulted in substantial flooding and flood damage (Fig. 3). Six flood-control dams failed, and others suffered damage. When dams failed, as in the case of one in the Upper Rullands Coulee drainage in Monroe County, large amounts of water were released downstream and caused substantial damage (Fig. 4).

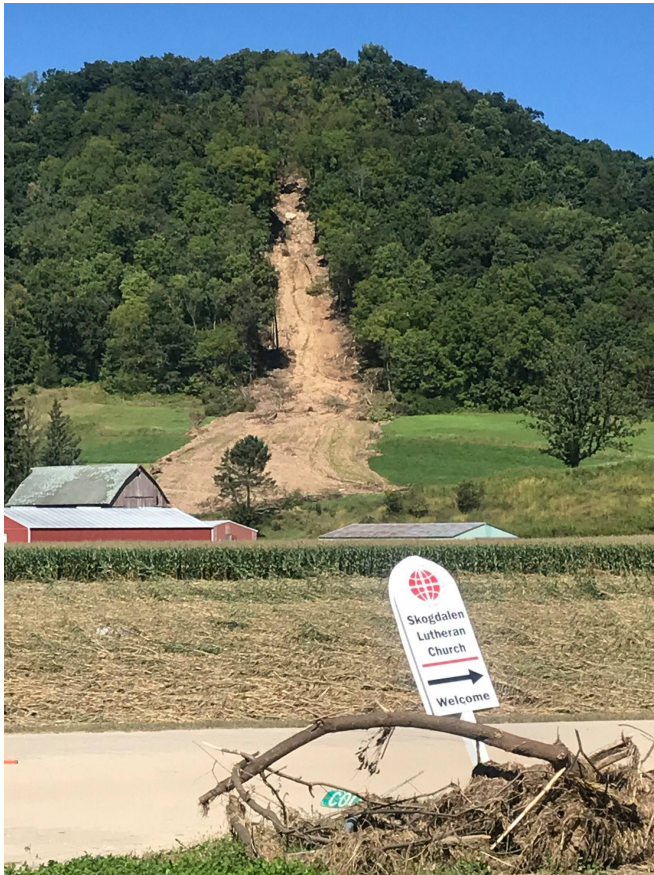
Fig. 4. Heavy rains created this mudslide above Skogdalen Lutheran Church, September, 2018. Credit. D. Welter.

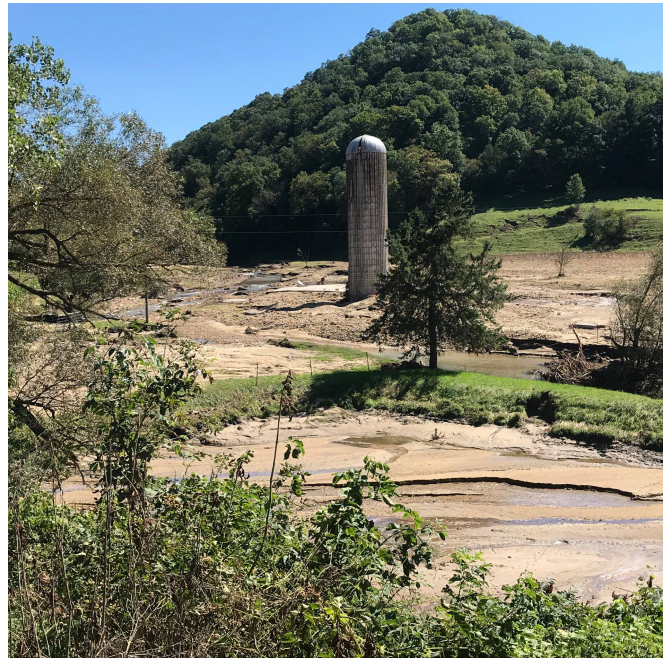
Fig. 5. Prior to September 2018 flooding, a barn and shed flanked this silo. Credit. D. Welter.

Rullands Coulee was a mess (Fig. 5), with barn and shed parts scattered across the landscape, and tipped-over gravestones at the Skogsdalen Lutheran Church. For many years, the late Palmer Olson had a small fly shop along Rullands, with a pond from an impounded spring where he would cast nearly every day. That pond's berms are gone, and his house sat cantilevered over an undercutting bank immediately after the flood. A tree slide on the ridge to the north of Rullands at County Highway P and Oakdale Avenue brought trees and mud 350 feet down a swath of hillside. Where box elders edged the stream, many were torn out and washed down into Timber Coulee where the stream became wide and shallow for some distance below the Highway P bridge. Some older restoration work in Timber Coulee (from the 1970s and 1980s) failed below the confluence, as did some older project work on Bohemian Valley.

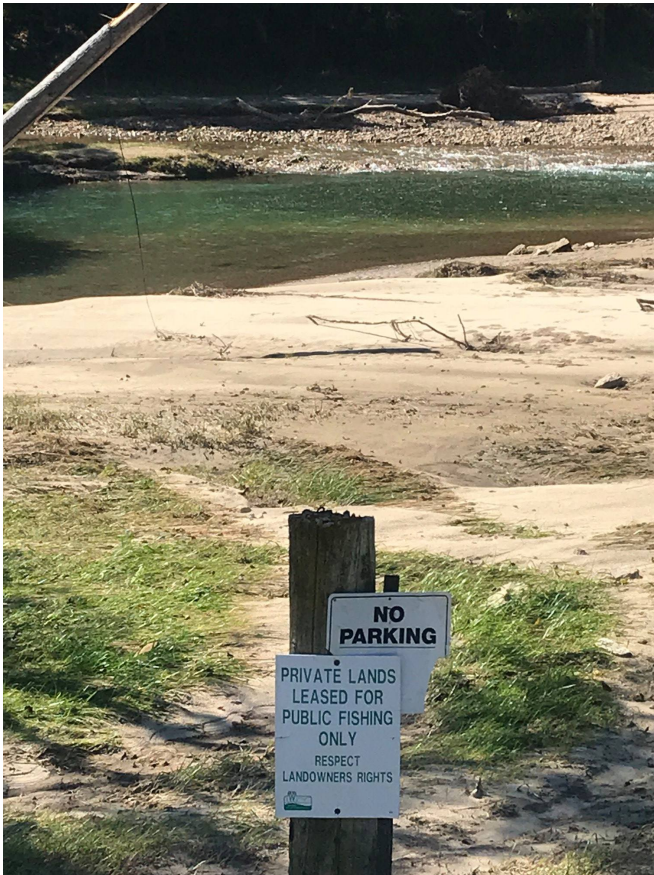
Fig. 6. The confluence of Rullands and Timber coulees, September 2018. Credit. D. Welter.

With the Midwest projected to see increased temperatures and more frequent high-intensity rainfall events likely to cause flooding (1–3), what do projected increases in precipitation and flooding mean for stream restoration in the Driftless Area? What do we know about the effectiveness of various elements of stream restoration and habitat improvement design, and how can they be used guide projects and better plan for resiliency in the face of extreme climate events (Fig. 6)? Stream and river restoration is still a relatively young discipline that
