# Pipeline Impacts to Water Quality

## Documented impacts and recommendations for improvements

August 21, 2019

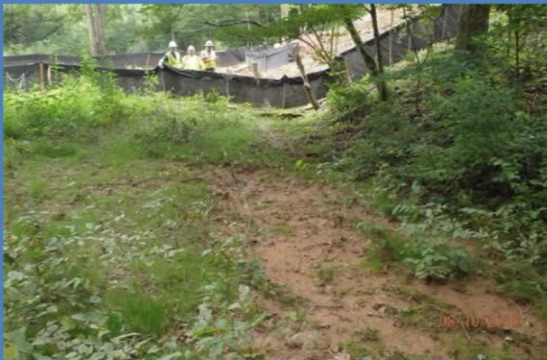
**Sediment trail leading to Laurel Run as a result of perimeter controls that were overwhelmed due to improperly installed and maintained waterbars**

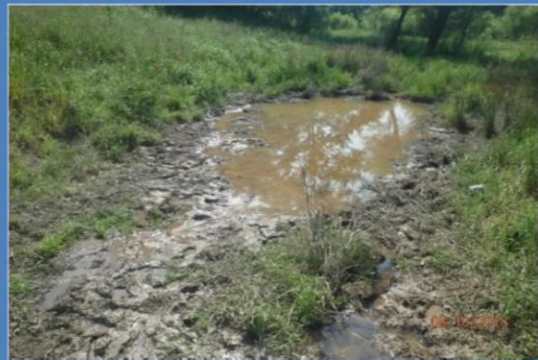
**Sedimentation that violates water quality standards in the Unnamed Tributary Kincheloe Creek wetland**

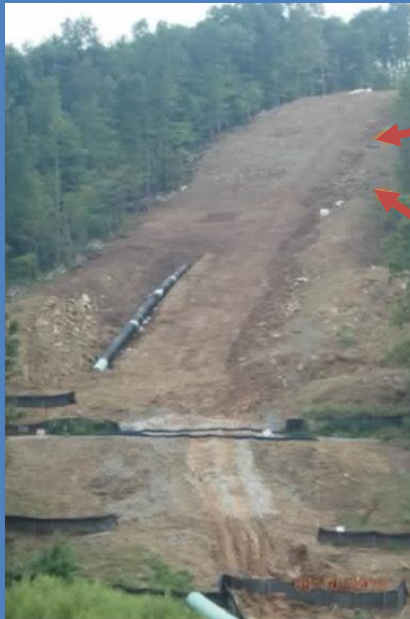
Diversion running parallel to the slope.

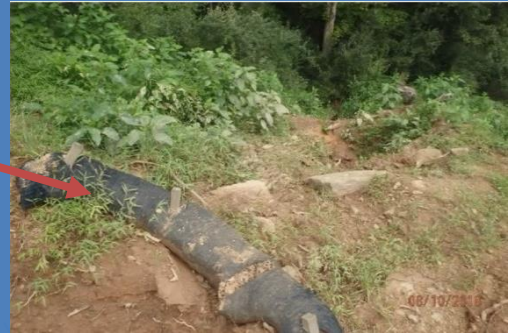
Waterbar outlet that has been overwhelmed, causing violations of water quality standards in the receiving stream.

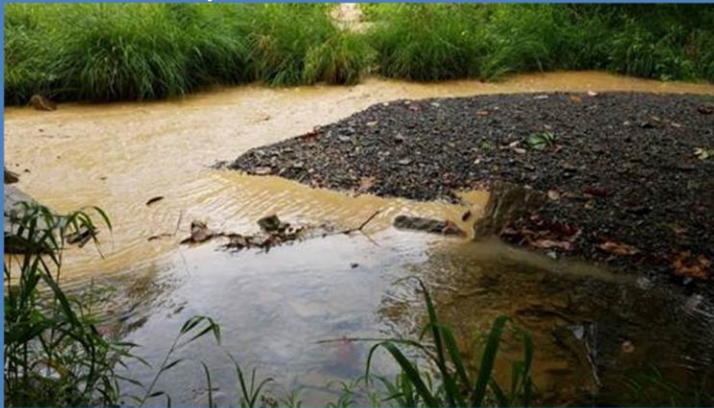
**A sediment-laden tributary enters Blue Lick in Monroe County, West Virginia, downstream from MVP construction, as documented by volunteers**

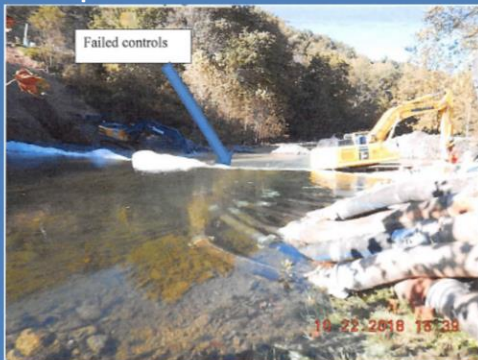
On October 22, 2018, a pump-around dam at the site of construction on the Seneca Rocks Compressor Station failed, and pumps were overwhelmed. This resulted in a sediment release to the North Fork of the South Branch of the Potomac River. The release violated West Virginia's water quality standards and three sections of the company's water pollution control permit. The NOV indicates that the company failed to report noncompliance to the state spill alert hotline and that the company failed to prevent sediment-laden water from leaving the site without going through an appropriate device.

Failed dam with approximately 20 intake lines upstream of the dam

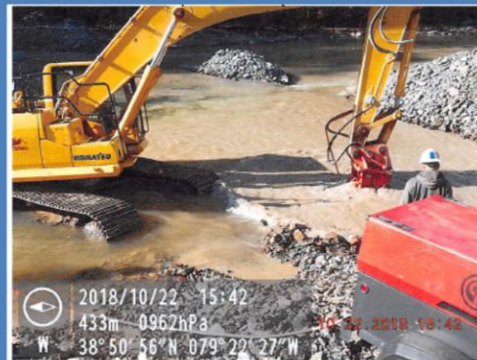
The North Fork of the South Branch of the Potomac River flows through the popular Seneca Rocks Recreation Area and is a highly-utilized trout fishery. Settleable solids from this release were observed 19 miles downstream in the South Branch of the Potomac River.

Construction continued and sediment-laden water caused violations of water quality standards in the North Fork of the South Branch of the Potomac River

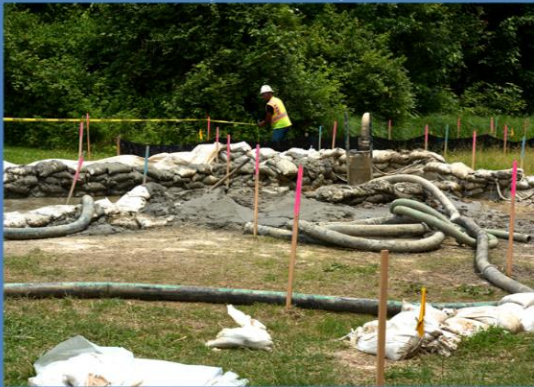
**Drilling mud released during an IR in Middletown (Dauphin County)**

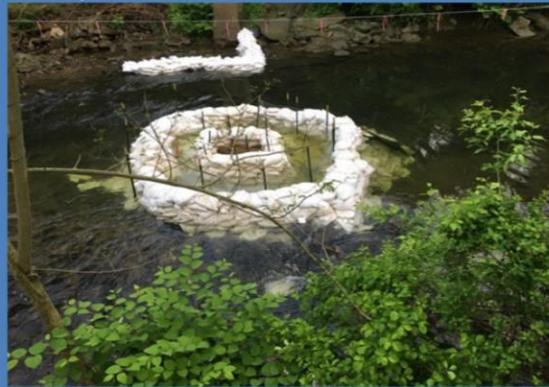
**Sand bags used to contain leak of drilling fluid on Chester Creek in Brookhaven (Delaware County)**

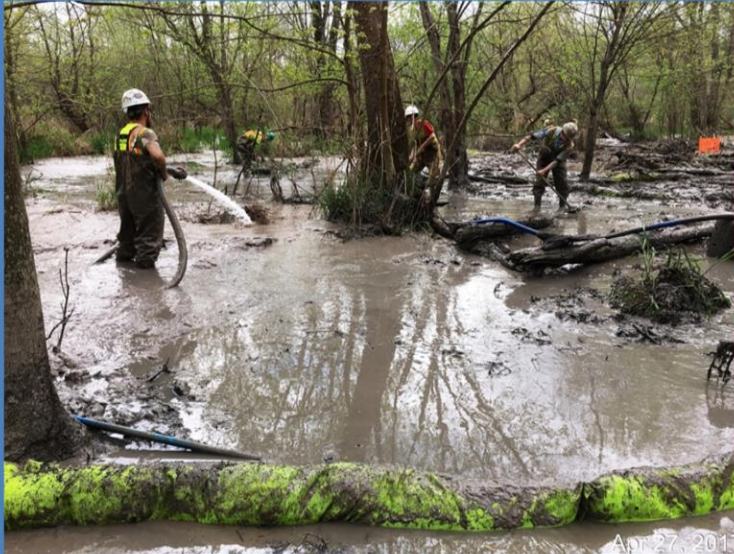
These were not isolated incidents. In January 2018, almost 150,000 gallons of drilling fluid were spilled at the same Tuscarawas River drill site (Chow, 2018). Additionally, 50,000 gallons of drilling fluid were spilled one day after the 2017 Stark County incident in Richland County, Ohio, and the following month 10,000 gallons of drilling fluid were spilled into a Harrison County pond and stream (Associated Press, 2017; Hendrix and Renault, 2017). Eleven incidents of drilling fluid being discharged into state waters were listed in legal proceedings (State of Ohio v. Rover Pipeline, 2017).

### Cleanup of drilling fluid in Tuscarawas River wetlands
