Mill Creek

Annual Environmental Monitoring Report WY2023

Prepared for the Wildlife Conservation Board
Prepared by: Trout Unlimited

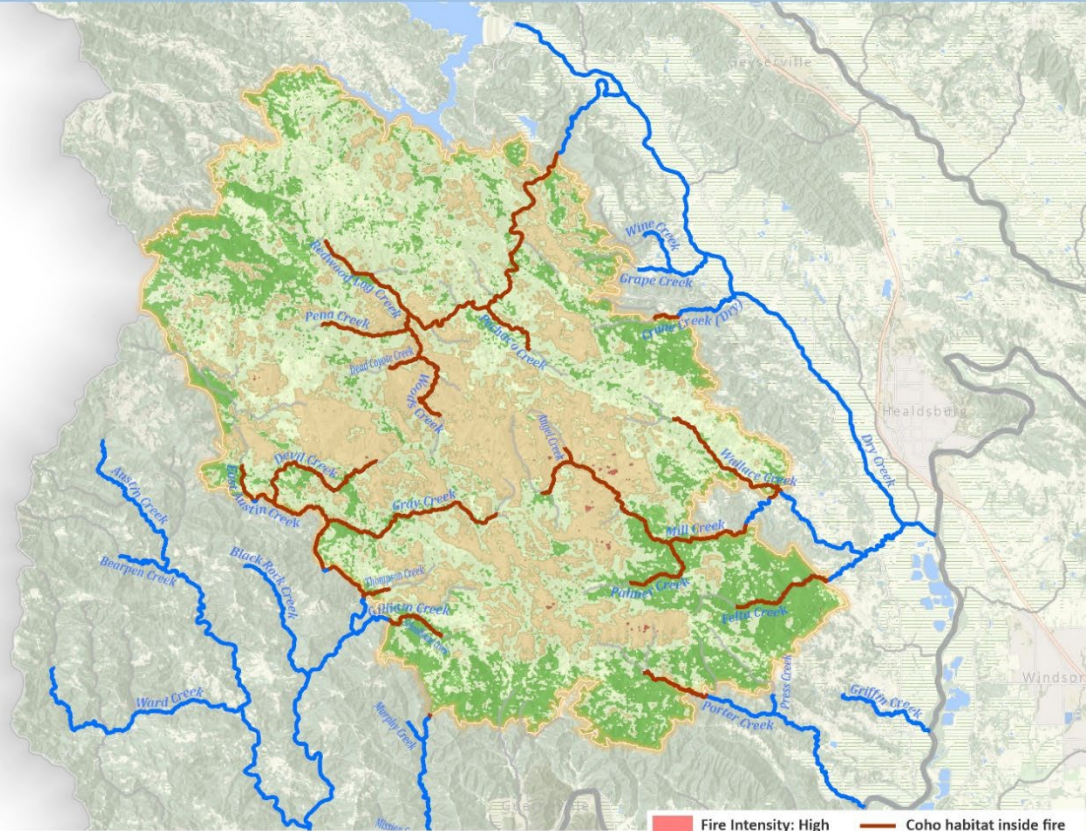
- Fire Intensity: High
- Moderate
- Low
- Very Low/Unburned
- Coho habitat inside fire
- Coho habitat
- Walbridge Fire Perimeter

Figure 2. The Walbridge Fire footprint and fire intensity in relation to coho salmon habitat in the lower Russian River basin, including the Mill Creek watershed.

In summer 2020 the Walbridge fire, part of the LNU Lightning Complex fires, burned the upper portions of the Mill Creek watershed. Between August 17 and October 2, 2020, the fire burned more than 55,000 acres and destroyed more than 150 homes in the rugged hills of northwestern Sonoma County. Sixty-three percent of all accessible salmonid habitat within the Mill Creek watershed was within the Walbridge Fire footprint (<https://caseagrant.ucsd.edu/blogs/the-walbridge-fire-and-salmon-habitat>). The upper extent of Mill Creek, Felta, Wallace and Palmer creeks experienced extensive burning of the upslope forests as well as the riparian corridor (Figure 2). The burn intensity was greatest in the furthest upstream reaches of Mill Creek, leaving this area exposed to far greater solar radiation and erosion potential than the rest of the watershed. The impact of the fire on streamflow and habitat conditions is largely unknown. This study is the first empirical data collected and evaluated post fire, and this report describes conditions three years after the fire. .

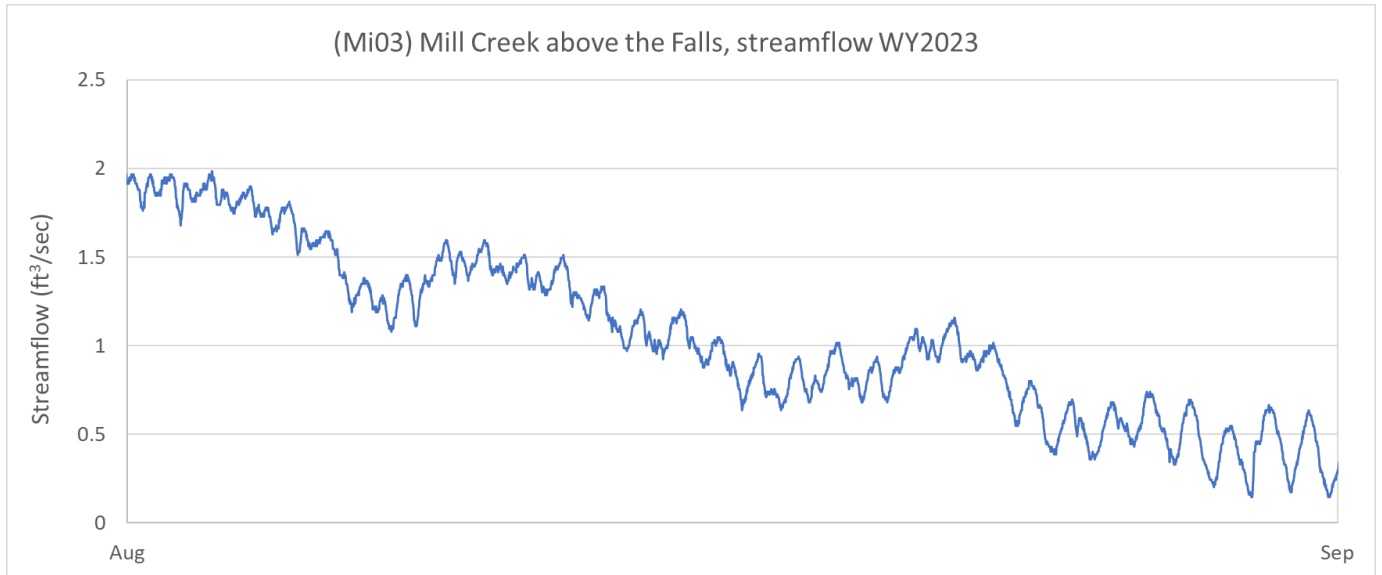
Figure 17. Streamflow at Mill Creek above the falls, WY2023, showing drops in streamflow caused by surface water diversions circled in red.

Figure 16 shows dry season streamflow conditions at Mill Creek Above the Falls in WY2023. Streamflow in early May 2023 was measured at approximately 14 ft³/sec. Flow slowly receded through May, June, August and early September to a baseflow of approximately 0.8 ft³/sec. Several drops in flow caused by surface water diversions are detected throughout the summer (Figure 15); however, the diversion signals recorded at Mill Creek at Mill Creek Lane do not match those recorded at the upstream gage site (Figure 12), this is likely due to alluvial deposits between the two gage sites. Small drops in flow, likely caused by surface water diversions, are recorded at sporadic intervals through the summer at a pumping rate of 0.17 – 0.2 ft³/sec.

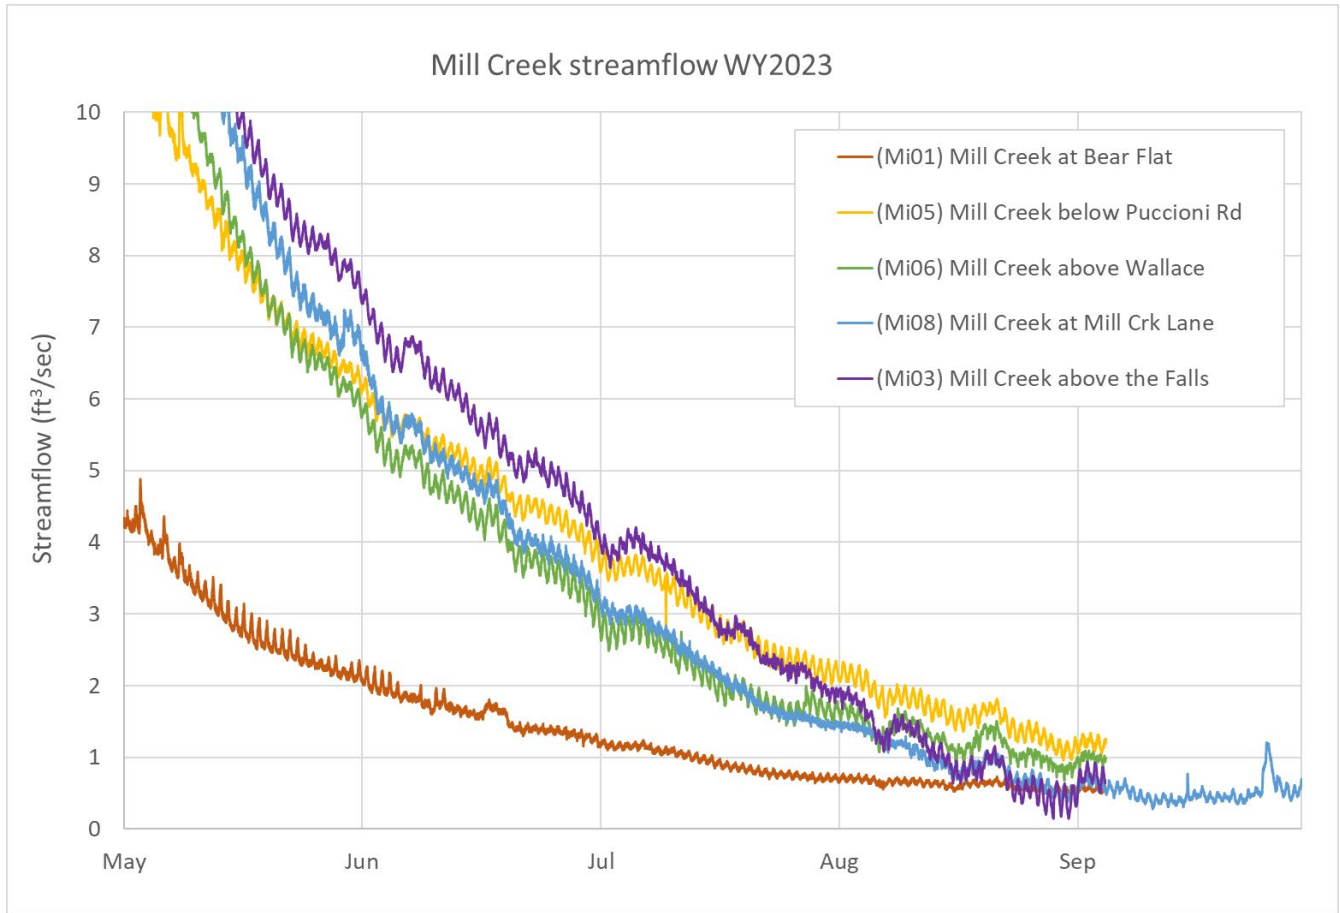
Figure 18. Streamflow at all Mill Creek sites, WY2023.

Figure 18 shows streamflow from May through September in WY2023 at all sites in the upper Mill Creek watershed. In the beginning of May streamflow increased from the most upstream gage site to the farthest downstream site (as you would expect with the increase in drainage area). This pattern began to shift in June, and by the time the system settled into baseflow in early September, the most downstream site (Mi03 had the lowest flow. Mi01 and Mi08 also had similarly low flows (~0.6 ft³/sec) while the further upstream sites (Mi06 and Mi05) had higher flows of about 1.0 and 1.3 ft³/sec, respectively. In this wetter year, all sites remained connected through early to mid-September.

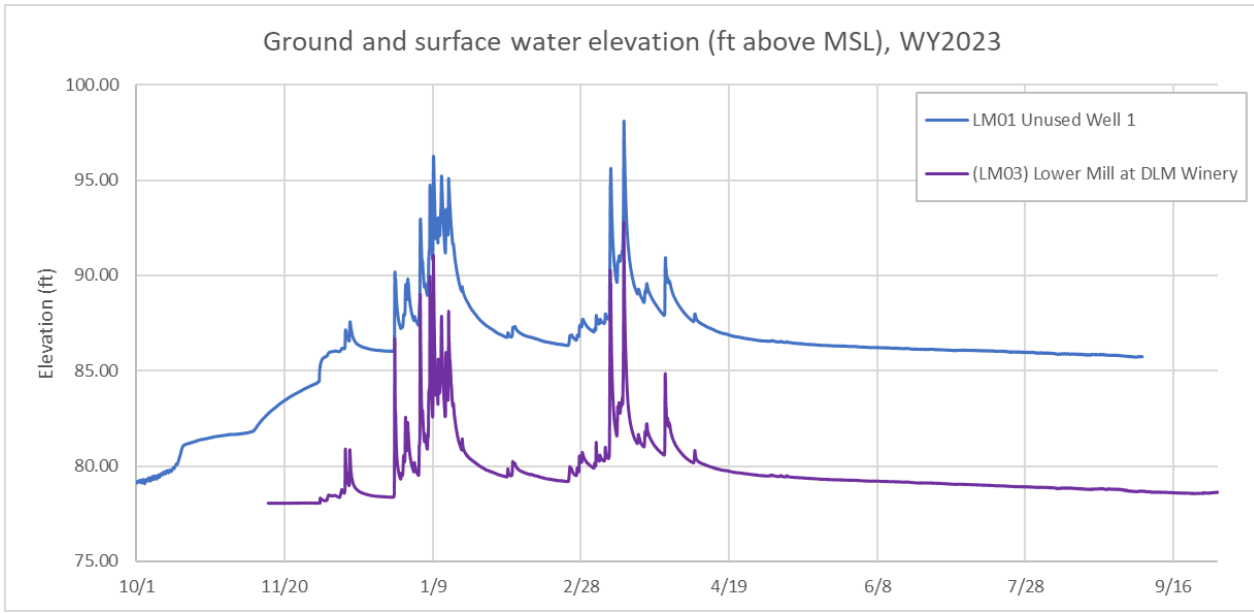
Figure 20. Continuous groundwater and surface water elevation, lower Mill Creek sites, WY2023.

Figure 21 shows continuous groundwater elevation in feet above mean sea level (MSL) at well LM01 (Unused Well 1) through WY2023, as well as the elevation of surface water LM03. LM01 is a well is adjacent to the channel about 0.5 miles upstream of surface water gage LM02. A datalogger in this well reads 15-minute elevation data year-round. Note that elevations at LM03 are about 7 feet lower than LM01 because LM03 is further downstream.

Early in WY2023 (October 2022), groundwater levels at LM01 were at a low of about 79 feet above MSL. Water levels rose in mid-October 2022 in response the season’s first small rain events. From late November through March, groundwater was reconnected with the surface water, and water levels at both sites rose and fell in response to winter storms. From April to through September, ground and surface water levels declined slowly, and did not drop as swiftly as seen in previous years. Groundwater reached a low point of 78.5 feet.
