Trickle Fill Project

West Tule Creek, South Fork of the Trinity River

In 2017, the [Watershed Research and Training Center \(WRTC\)](#), based in Hayfork, California began working on the West Tule Creek Fish Passage and Trickle Fill Project.

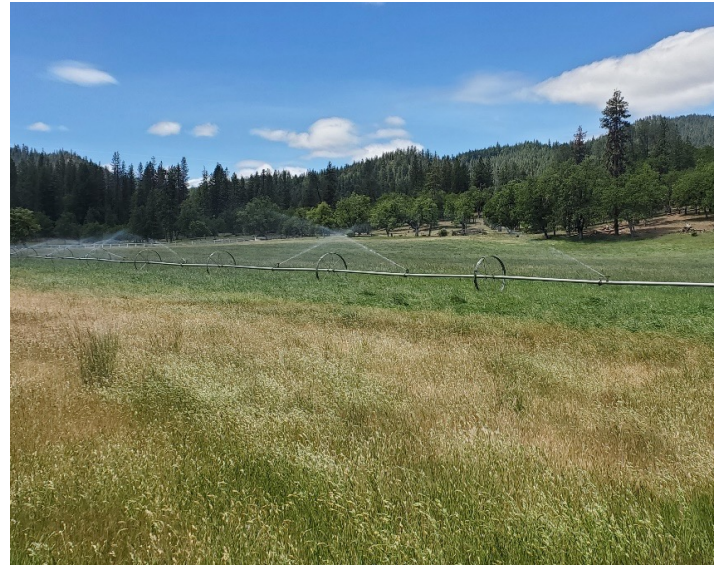
Figure 1. One of five fields being irrigated using water from the trickle fill pond.

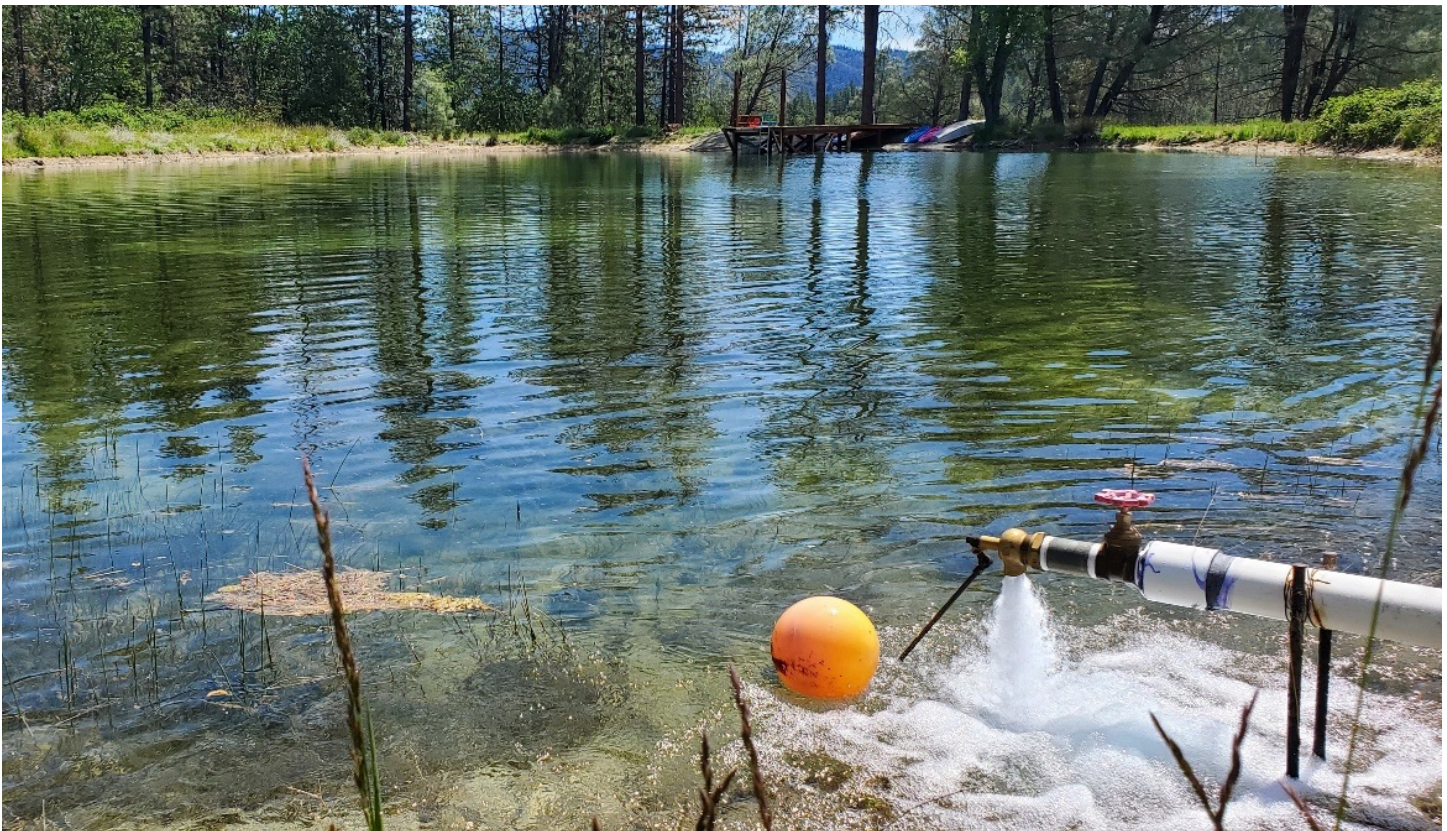
Figure 2. The trickle fill pond is being filled prior to the forbearance period. Note the orange ball attached to a float valve to stop the flow when the pond is full.

The goal was to remove an existing fish barrier and replace the diversion with a fish friendly structure and fish screen. The project also upgraded the current irrigation infrastructure from an “on-demand” to a “trickle-fill” system that utilized a pre-existing storage pond. This new “trickle-fill” system would deliver a smaller amount of water to the pond consistently. The existing “on-demand” system diverted a larger amount of water from the stream- resulting in the periodic drying of West Tule Creek downstream.

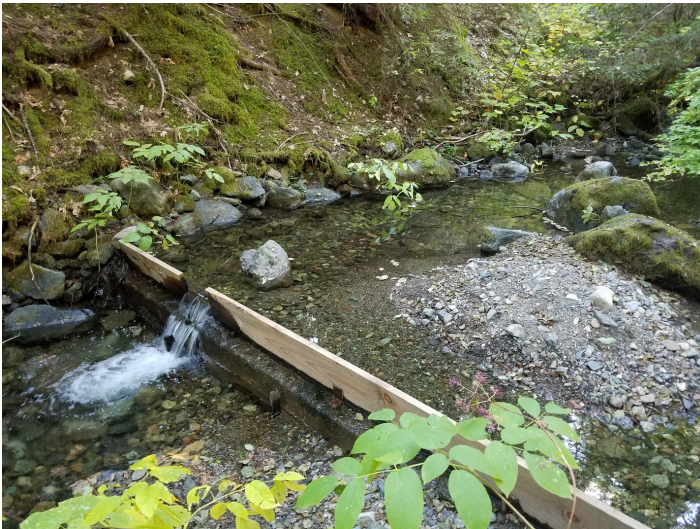
Figure 3. The current diversion that will be replaced with a fish friendly structure.

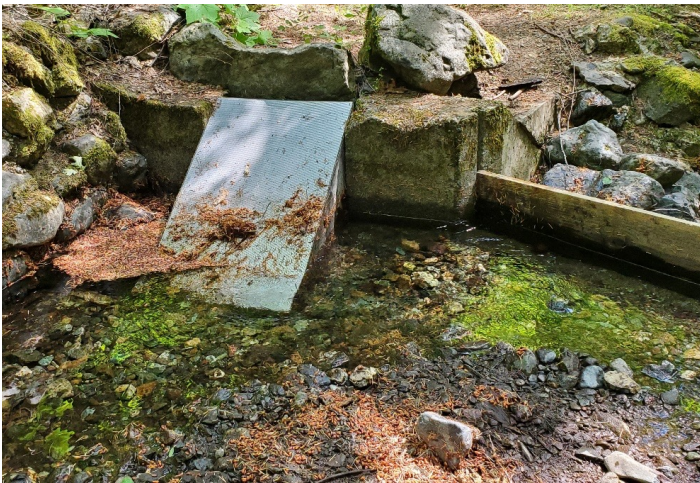
Figure 4. The current fish screen that will be replaced with a lower maintenance screen.
